Re: Administrative Order No. CWA 04-2011-4771  
NPDES Permit No. NCG200339

**ADMINISTRATIVE ORDER**

Water Compliance Inspection Report

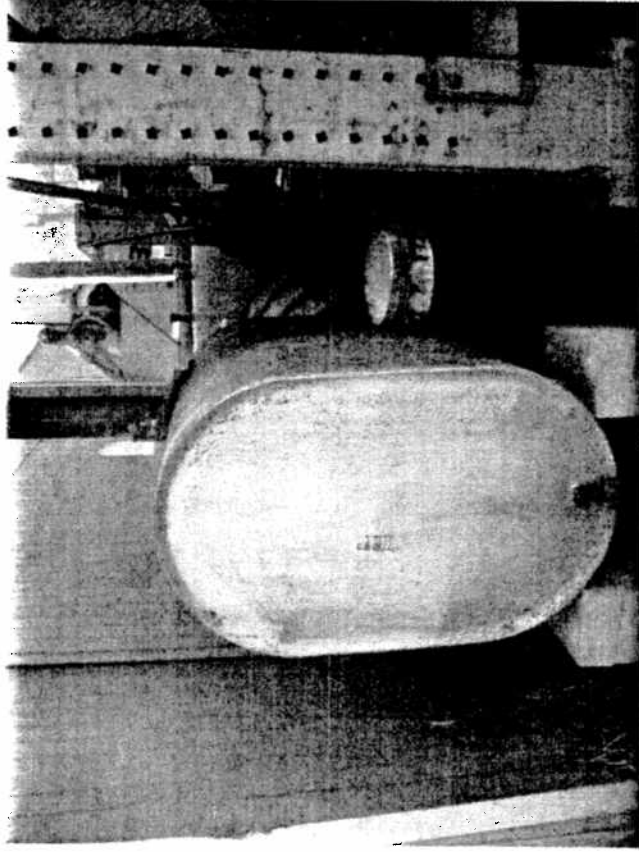
3

Pollutant Sources	Note location, quantitative description, design issue, O&M deficiencies (including the nature and extent), and pollutants off-site
Loading/Unloading Area	There was loading/unloading area with a scale near the main office, Photo #9.
Outdoor Storage Facilities	A majority of the property was used for outside storage/processing operations of scrap metal materials, Photos #12, 13, 14, 15, 16, 17, 18, 19, 20, 21, 22, 23, 24, 26, 32, 33, 34, 35, 37, 38, and 39.
Outdoor Manufacturing/Processing Operations	See above "Outdoor Storage Facilities" However, there were indoor processing operations inside the non-ferrous warehouse that included a baler for soda can compaction, Photos #40 and 41.
Dust Generating Activities (Dirt roads? Dust control plan?)	Not applicable.
Waste Treatment/Storage/Disposal Areas	Three (3) 275 gallon tanks and one (1) 150 gallon tank were observed near the vehicle fluid draining area outside of the maintenance shop, Photos #2, 3, and 5.

- Photo #3- View of tanks looking west.
- Photo #4- View oil staining near the car that was being drained of fluids in Photo #1.
- Photo #5- Another view of the tanks looking northeast.

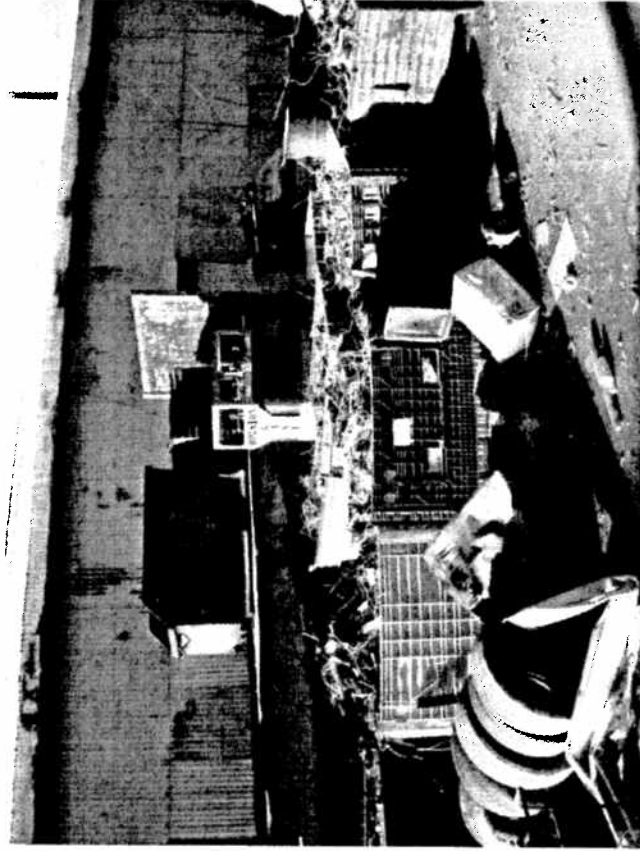
39

- Photo #39- Closer view of Photo #38. Note ballasts were observed in the bins. However, they did not contain PCBs per Mr. Jeff Cloninger.
- Photo #40- View inside the non-ferrous warehouse on the northeastern portion of the property.

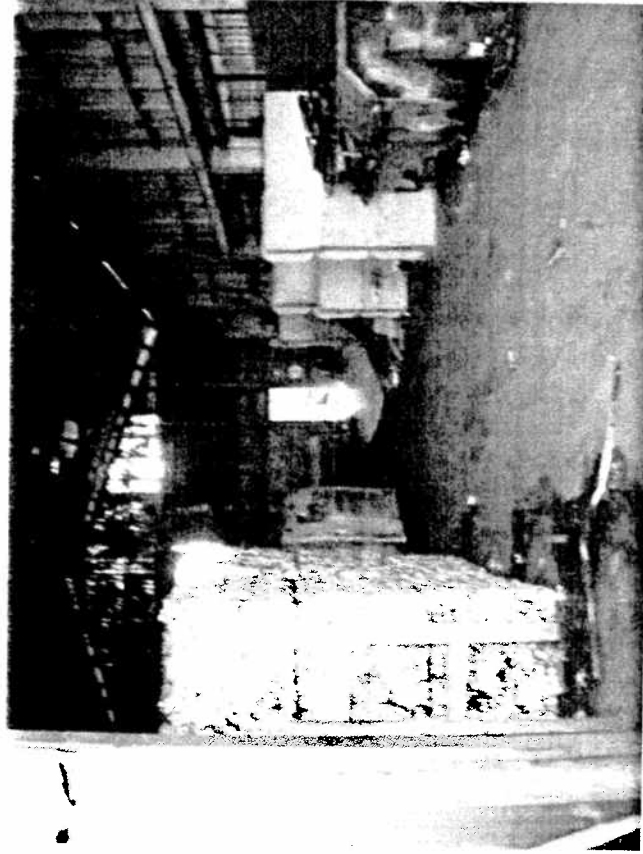
41

- Photo #41- Another view of Photo #40
- Photo #42- View of BIMCO entrance facing Meadow Rd.
